Manhole Inspection Summary

Manhole # S23M__011MH

Insp Date: **6/19/08 3:00 PM**

Location Address: **1615 Ramsey St**

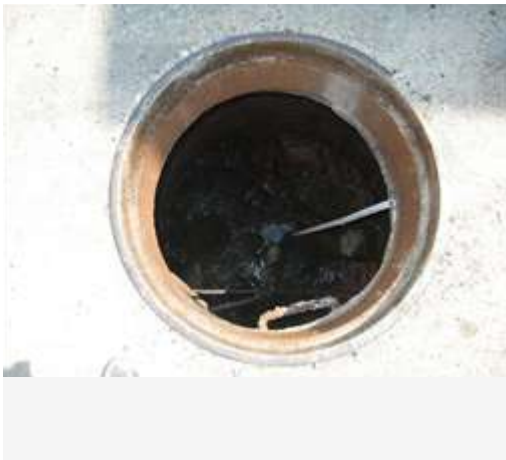
Frame View

Condition: ☐ Sound ☐ Cracked ☒ **Leaks**

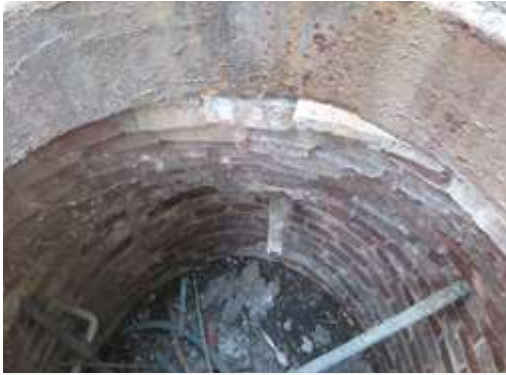
Defect 2

Condition: ☐ Sound ☐ Cracked ☐ Root Intrusion ☒ **Loose Brick** ☐ Deteriorated

Infiltration: ☐ None ☒ **Joint** ☐ Cracks ☐ Mortar ☐ Roots ☐ Wall

Frame infiltration, Loose Bricks in Chimney, Chimney Infiltration

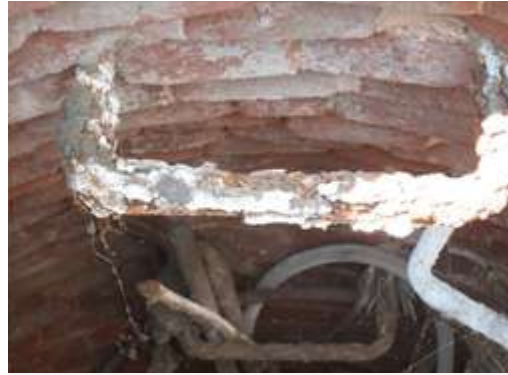
Defect 3

Count: **4** Missing: **0** ☒ **Corroded**

☒ **Evidence Of Surcharge** Depth: **1.5** (ft.) ☒ **Active Surcharge Present**

Corroded rungs, Surcharge Evidence

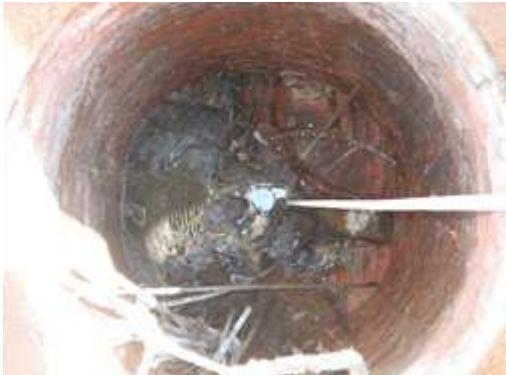
Defect 1

Condition: ☐ Sound ☐ Cracked ☐ Root Intrusion ☐ Deteriorated ☐ Leaks ☒ **Debris**

Bench Debris, Channel Debris

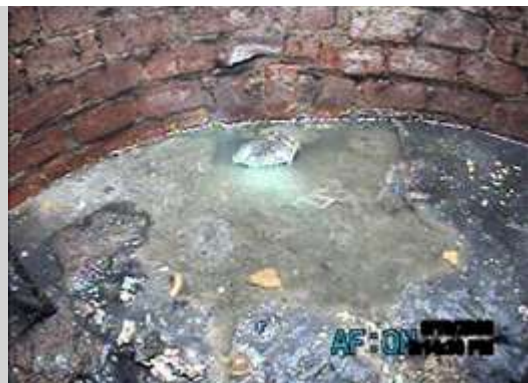
9 O'Clock Inflow

evidence of surcharge

Deposits: ☐ None ☒ **Mud** ☒ **Sludge** ☒ **Debris** ☐ Grease

Silt Depth: **8** (in.) Deposits Extent: **Heavy**

Comments **9 oclk pipe needs cleaning**
